A13-OLinuXino-WIFI-DEV
step-by-step VGA hardware fix

This document applies ONLY to the very first batch of A13-OLinuXino-WIFI-DEV boards, which were sold with a problem in the VGA output with shipping costs covered by OLIMEX. As written on our page prior to selling the boards:

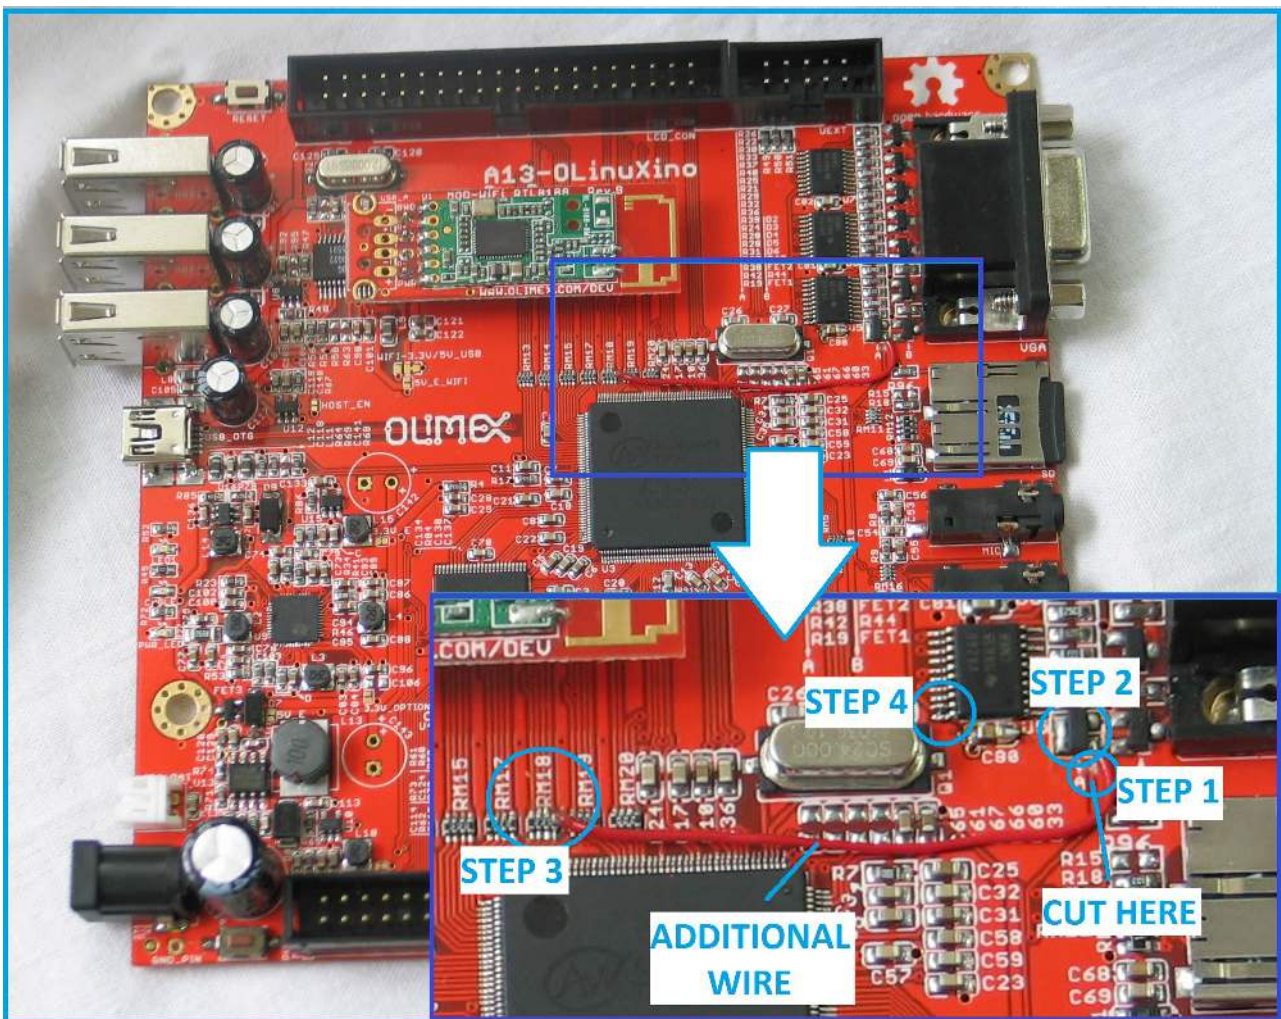
Following the picture (the picture shows the fix applied) below we need to do 4 steps:

STEP 1 – Cut carefully the wire under R19 (which is not mounted) using a sharp knife or a proper tool. **IMPORTANT: if you don't disconnect the wire the workaround will not work.**

STEP 2 – 1. Unsolder R42 (over R19 pads);

2. On the now clear pads of R19 and R42 we solder the transistor mentioned in requirements – BSS138 or any NMOS transistor in SOT-23 package – its gate should be on the R19 right pad (check the picture how the transistor is situated);

3. Solder one end of the wire to the gate of the transistor

STEP 3 – Solder the other end of the wire to the 4th resistor of resistor matrix RM18 (RM18G4 on the schematics)

STEP 4 – Solder a 1k Ohms resistor between pin19 and pin20 of the U5.
