# Mobile Intel® Celeron® Processor on .13 Micron Process in Micro- FCPGA Package

Specification Update

*September 2004*

Document Number: [251309-022](#)

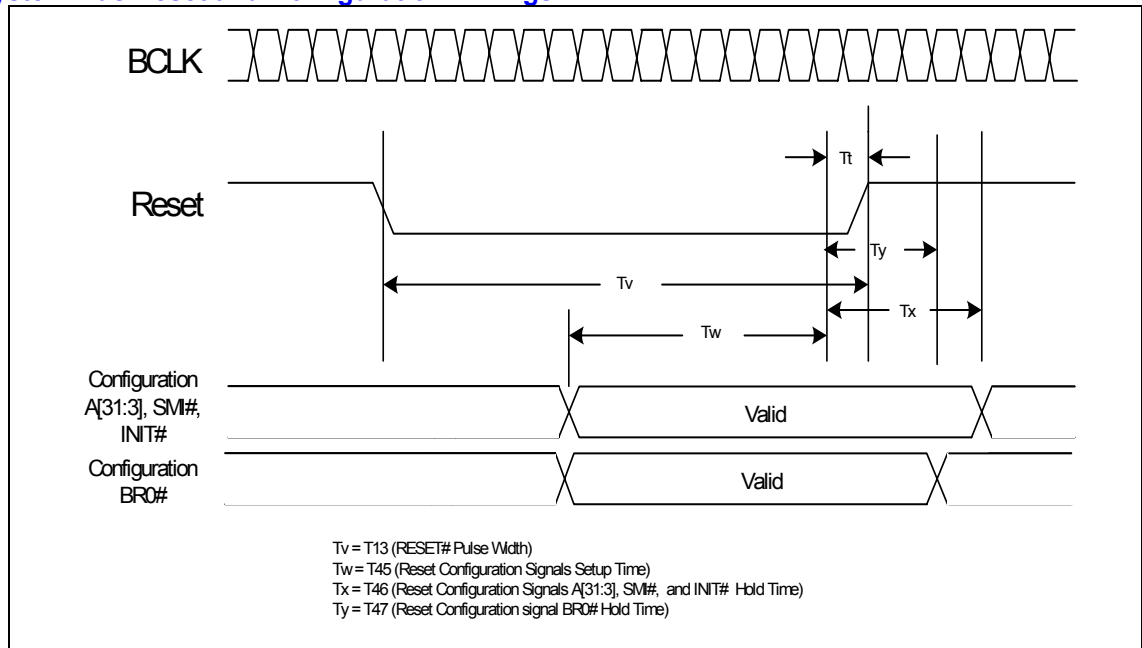
**Figure 12. System Bus Reset and Configuration Timings**

The BR0# maximum hold time has changed to 2 BCLKs. This change will be shown in the “System Bus AC Specifications (Reset Conditions)” table and “System Bus Reset and Configuration Timings” figure of the *Mobile Intel® Celeron® Processor on .13 Micron Process in Micro-FCPGA Package Datasheet*. This change will be incorporated in the next revision of the datasheet.

The following figure is modified to reflect this change:
