Mobile Intel[®] Pentium[®] 4 Processor-M

Specification Update

September 2004

Document Number: [250721-025](#)

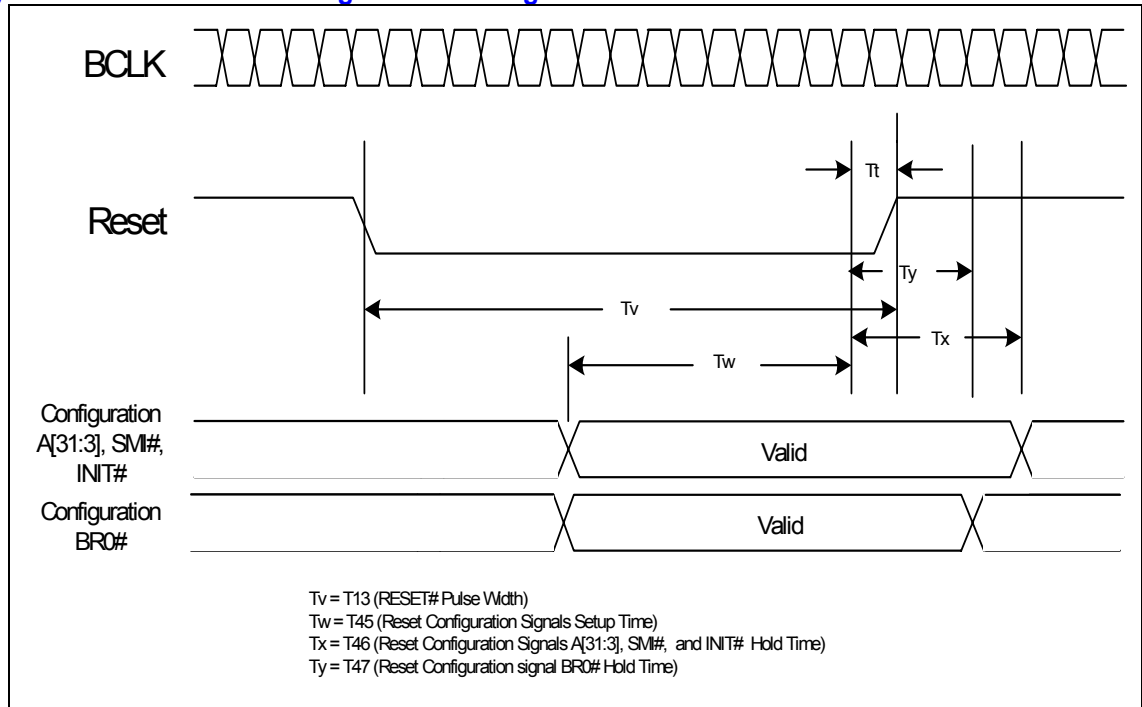
Figure 13. System Bus Reset and Configuration Timings

The BR0# maximum hold time has changed to 2 BCLKs. This change will be shown in the “System Bus AC Specifications (Reset Conditions)” table and “System Bus Reset and Configuration Timings” figure of the *Mobile Intel® Pentium® 4 Processor - M Datasheet*. This change will be incorporated in the next revision of the datasheet.

The following figure will be modified to reflect this change:
