Inductive Sensors  
**BES R05KB-NSC20B-EP05**  
Order Code: **BES01YZ**

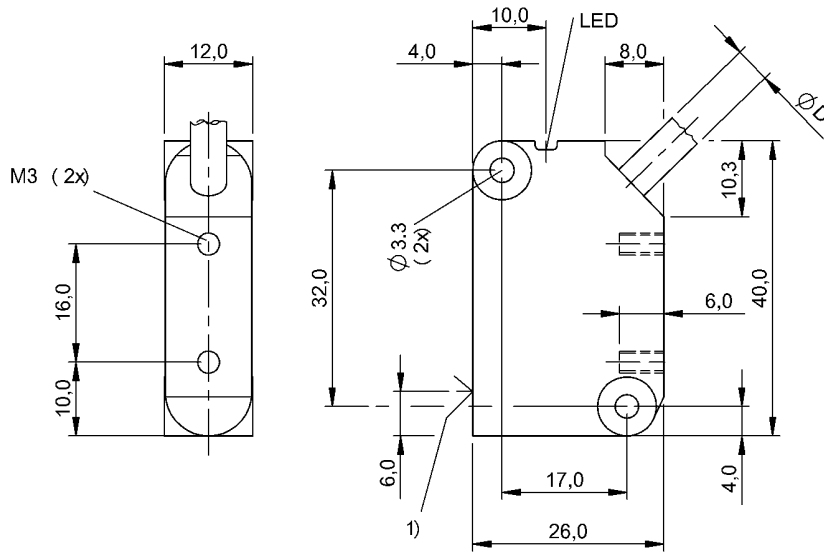
1) Sensing surface Ø8
