REV.	PART NUMBER LPI-C011701S-150R	<p>CONFIDENTIAL INFORMATION</p> <p>THE INFORMATION CONTAINED IN THIS DOCUMENT IS THE PROPERTY OF LUMEX INC. EXCEPT AS SPECIFICALLY AUTHORIZED IN WRITING BY LUMEX INC, THE HOLDER OF THIS DOCUMENT SHALL KEEP ALL INFORMATION CONTAINED HEREIN CONFIDENTIAL AND SHALL PROTECT SAME IN WHOLE OR IN PART FROM DISCLOSURE AND DISSEMINATION TO ALL THIRD PARTIES.</p>

<p>290 E. HELEN ROAD PALATINE, IL 60067-6976 PHONE: +1.847.359.2790 US WEB: www.lumex.com TW WEB: www.lumex.com.tw</p>
SINGLE UNIT PANEL MOUNT FLEXIBLE LIGHT TRANSPORTER, RED LENS.		<p>RELIABILITY NOTE</p> <p>OUR MANY YEARS OF EXPERIENCE DATA ACCUMULATION INDICATE THAT SOLDER HEAT IS A MAJOR CAUSE OF EARLY AND FUTURE FAILURE. PLEASE PAY ATTENTION TO YOUR SOLDERING PROCESS.</p>	<p>DRAWN BY: GT</p> <p>CHECKED BY:</p> <p>APPROVED BY:</p>
		DATE: 9.16.02	PAGE: 1 OF 1 SCALE: N/A

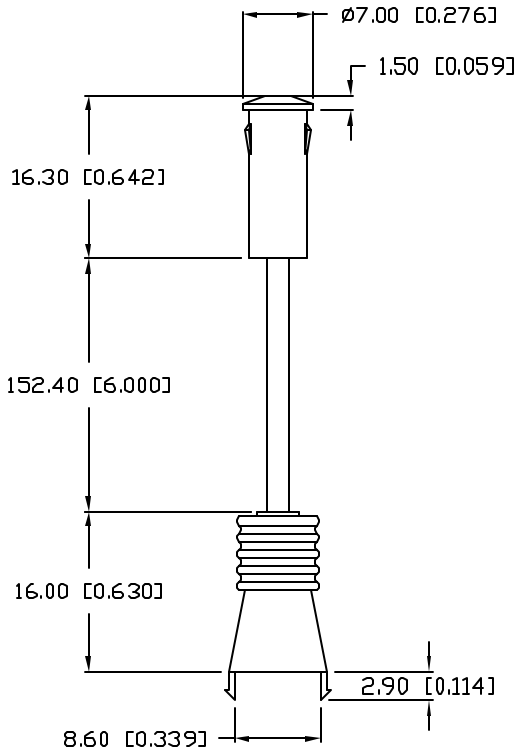
PANEL CUT OUT: $\phi 6.00\text{mm}$.
PANEL THICKNESS: $1.80\text{mm} \sim 4.80\text{mm}$.
