PART NUMBER
SSA-LXB8835

REV.	PART NUMBER
A	SSA-LXB8835
101 LED BAR GRAPH ARRAY, 565nm SUPER GREEN LEDS, WATER CLEAR LENS.

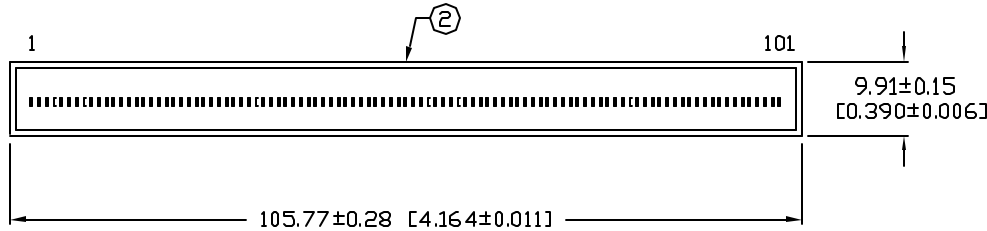
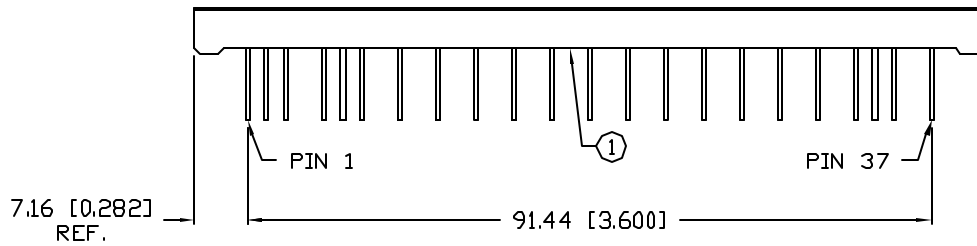
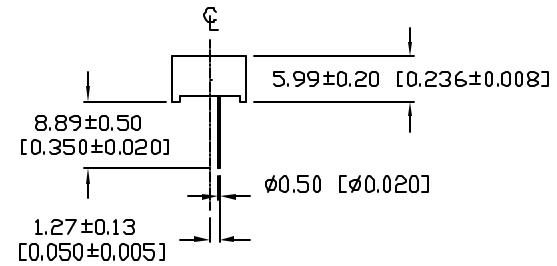
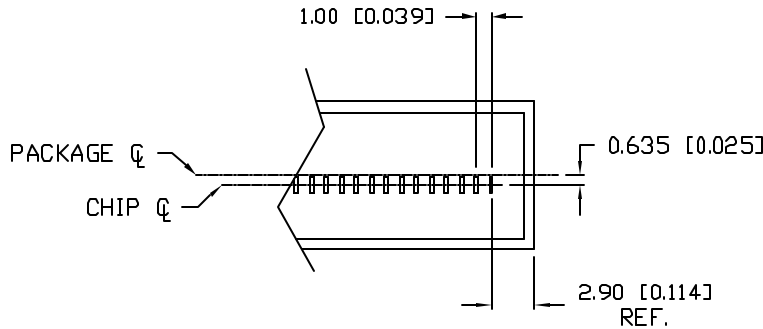
1. 37 PIN LOCATIONS ON 2.54 [0.100] CENTERS.
2. 0.25 [0.010] x 0.75 [0.030] RAILED EDGE.
3. NO PIN LOCATION 4, 8, 10, 12, 14, 16, 18, 20, 22, 24, 26, 28, 30, 32, 36.
4. TOLERANCES ARE NON-ACCUMULATED ON 101 LEDS.
