1 11 07	STAMP C1 WAS CUT THRU		www.keyelco.com • NEW HYDE PARK, NY 11040 • Tel (516) 328-7500 PART NAME
1.11.23	CHANGE AS PER ECN 23-026	С	2032 COIN CELL SM RETAINER
			MATERIAL DE CONTRA DE CONT
	ADDED NOTE 1.		.010 [0.25] TH'K PHOSPHOR BRONZE
3.30.20	CHANGE AS PER ECN 20-031	В	FINISH TIN NICKEL PLATE PRINT SCALE 9.19.18
	REMOVE DIMPLES		TIN NICKEL PLATE APP'D RH SCALE 2.5X
5.13.19	CHANGE AS PER ECN 19-053	A	TOLERANCES INCH [MM] CODE DWG NO. DECIMAL ± .010 [± 0.25]
DATE	DESCRIPTION	REV.	ANGULAR ± 1° UNLESS OTHERWISE SPECIFIED C 2898

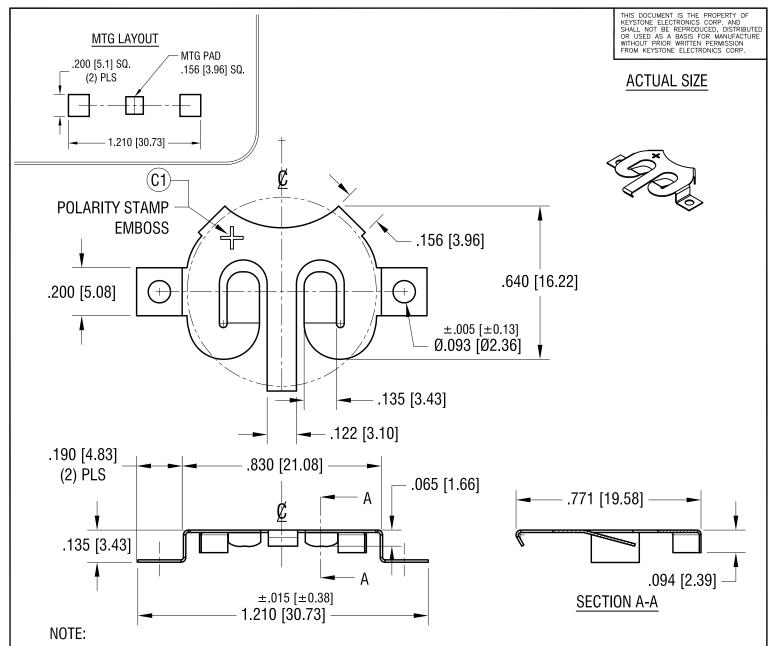
- 1. NO DISLODGMENT OF THE CELL OR DAMAGE TO RETAINER WITH THE FOLLOWING TESTS:
 - a) INTEGRITY VIBRATION TEST PER MIL-STD-810G METHOD 516.6
 - b) SHOCK TEST PET MIL-STD-810G METHOD 516.6
 - c) BENCH HANDLING SHOCK TEST PER MIL-STD 810G METHOD 516.6
 - d) TRANSIT DROP TEST PER MIL-STD 810G METHOD 516.6
